MAINTENANCE ISSUES, RECOMMENDATIONS, AND SPECIFICATIONS

This section is a compilation of major maintenance recommendations for all trail field assessments in January and March, 2003. The issues and recommendations have been prioritized to help guide the park in implementation of work. The subsequent sections of this chapter contain detailed specifications on how to accomplish these projects. The highest priority maintenance needs relate to large volumes of water, moving at high speed along or across the trail, causing extensive erosion and gullyng of the treadway. Repairs needed include:

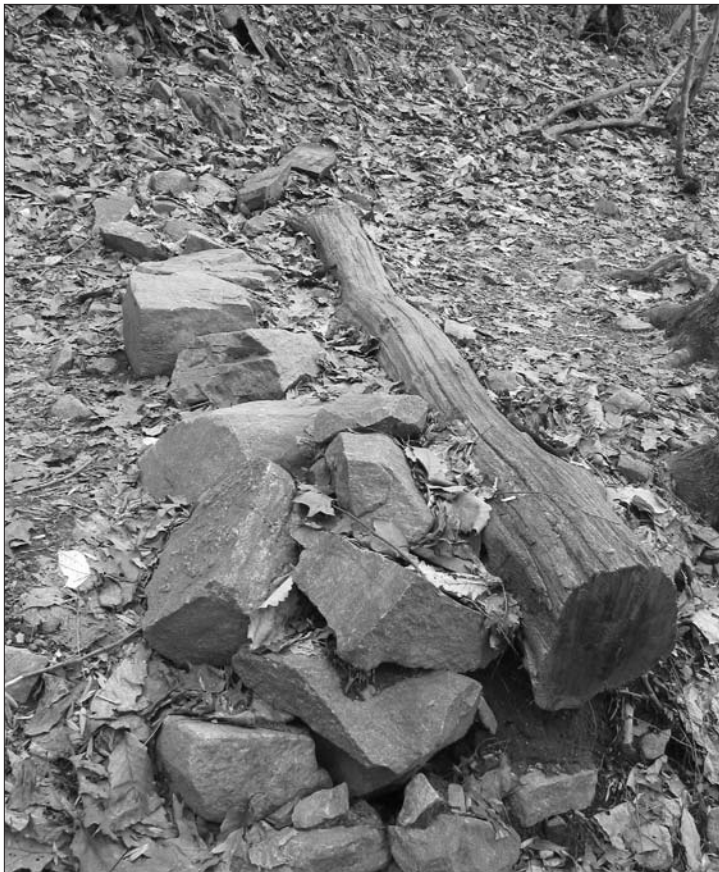
Figure 4.36. Deteriorating stone check on Horse-Shoe Trail A has been backed with a log retainer bar.

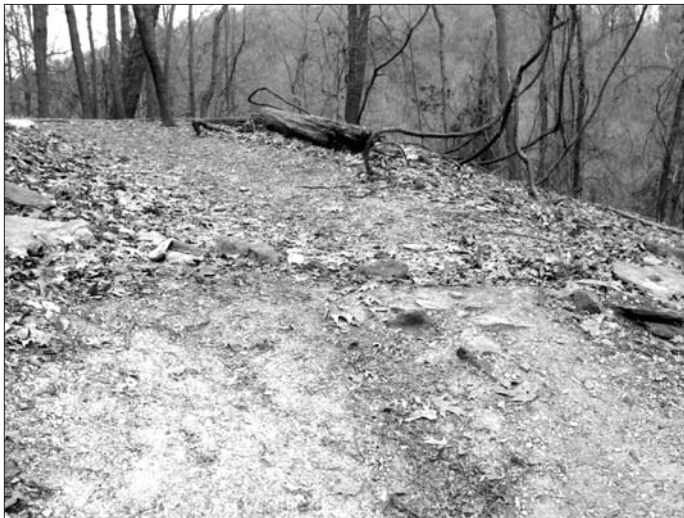
Figure 4.37. Check on Mount Misery C that needs repair. The trail is washing out above and below and causing a gully down the treadway.

Recommendation: Construct checks to repair gullies or retain tread material on steep slopes.

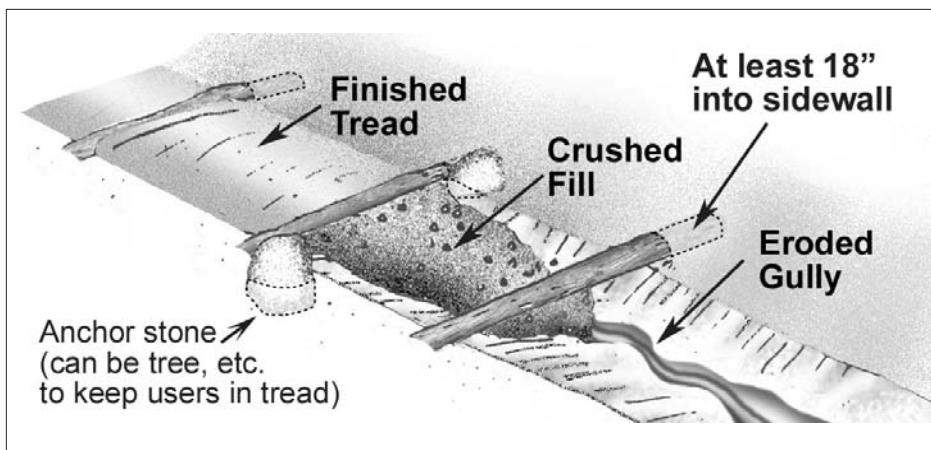
Figure 4.38. Diagram for log checks. Adapted from Griswold, 1996.

Specifications: Check logs or rows of stones are set perpendicular to the trail. The checks are backfilled with rubble and then covered with a top coat of tread material. To prevent failure of the checks due to continued erosion or a lack of maintenance, the bottom of each check is placed at an elevation below the top elevation of the preceding downhill check. The checks act as “hidden steps” underneath the tread surface, holding back, or “checking” the uphill fill material. In worst-case scenarios where tread material wears away and is not replaced, checks hold the remaining treadway in a series of flat terraces (Figures 4.39 and 4.40).

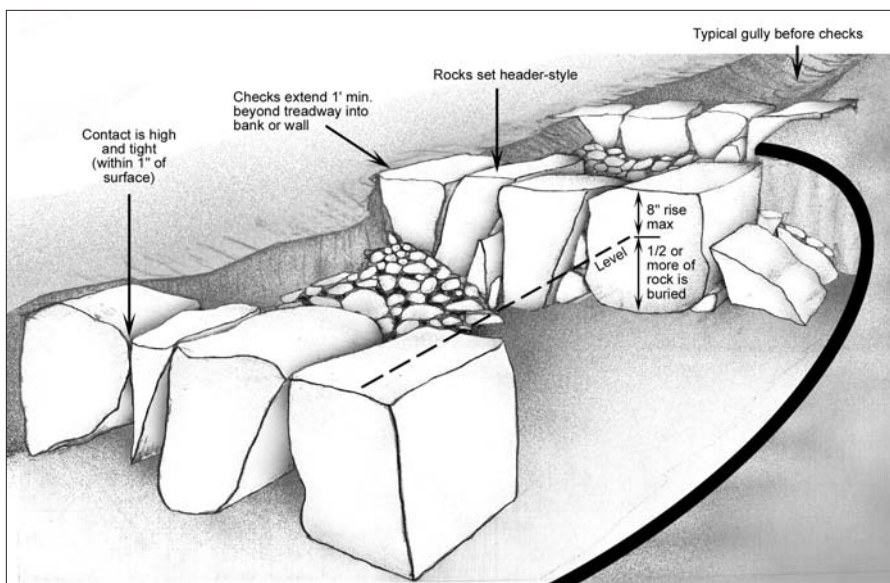
Figure 4.39. Stone check specifications for Acadia National Park.

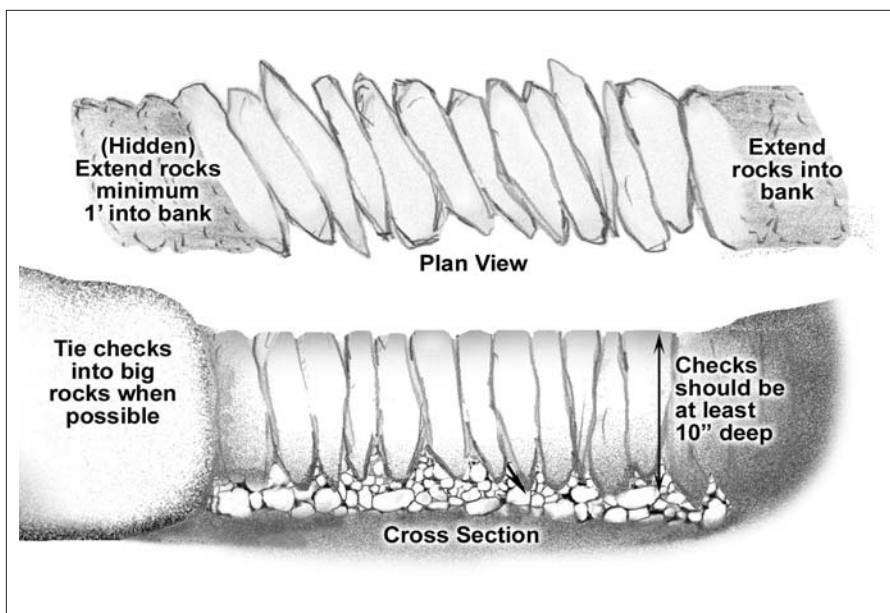
Figure 4.40. Constructing stone checks with small flat rocks indigenous to Valley Forge NHP.

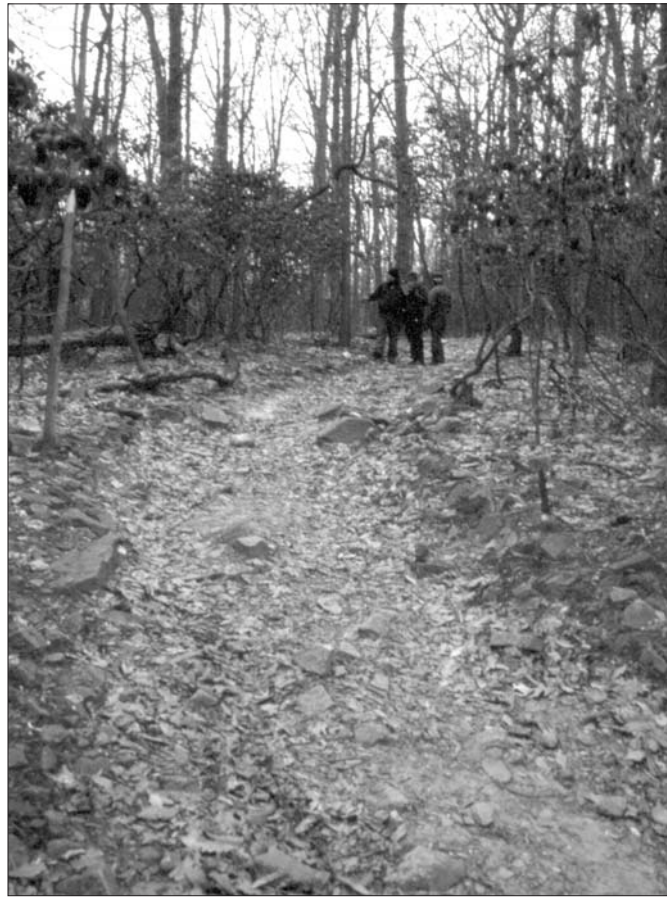
Figure 4.41. Segment of Horse-Shoe Trail A in need of log cribbing.

Recommendation: Repair heavily eroded steep sections with log cribbing.

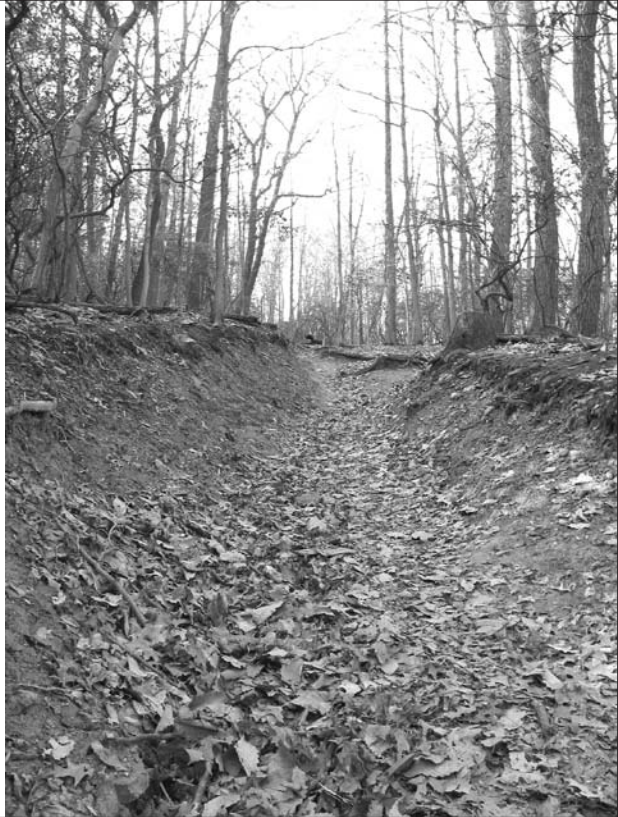
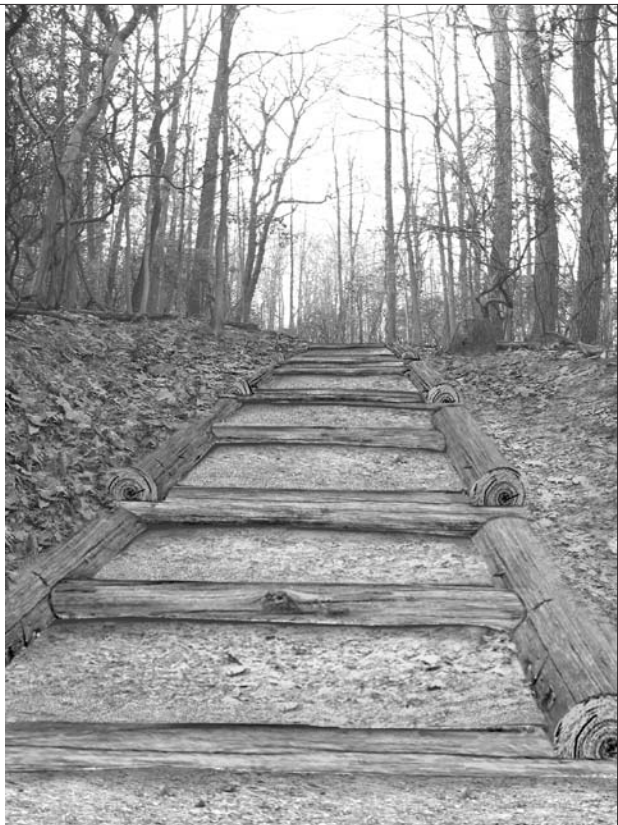
Figure 4.42. Example of a proposed crib step and check project.

Massive gully on Mount Joy D is up to five feet deep

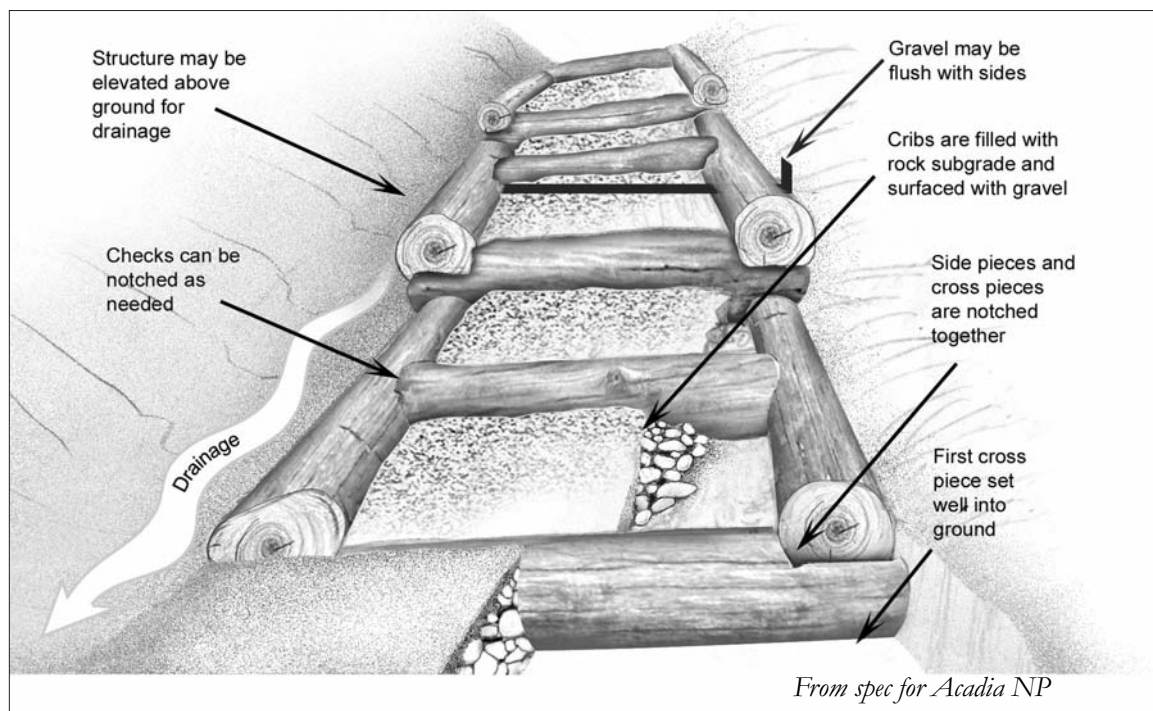
Figure 4.43. Detail of crib steps with checks.

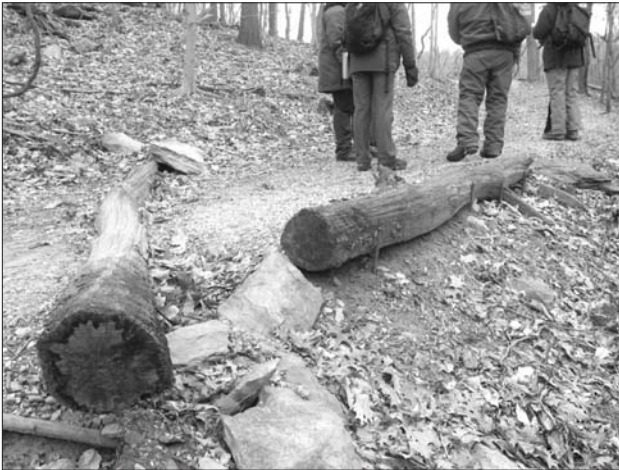
Figure 4.44. This retaining bar and water bar on Mount Misery B are being eroded. To prevent undermining of the logs, reset the water bar to the correct depth and at the grade of the trail on the uphill side. Solidly set swale outlet stones between water bar and retaining bar and make sure stones have good contact both with each other and with the logs.

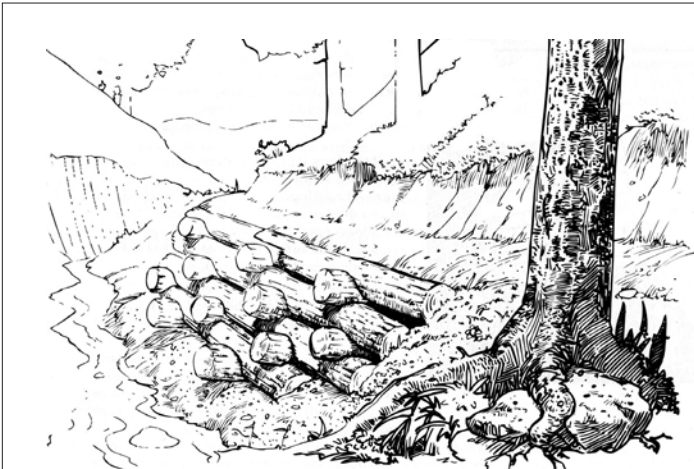
Figure 4.45. Multi-tiered Log Retaining Wall. From Birkby, 2000, 195.

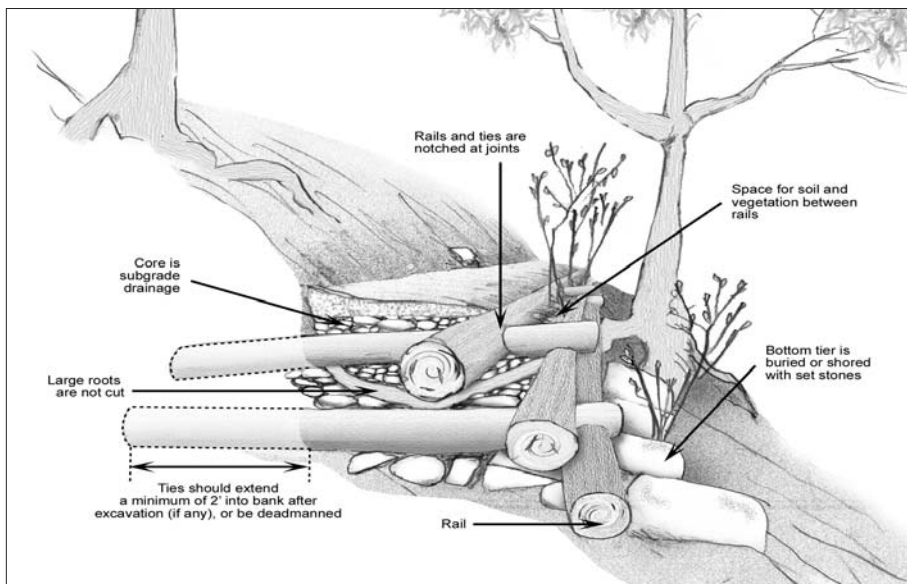
Figure 4.46. Detail of walled crib.

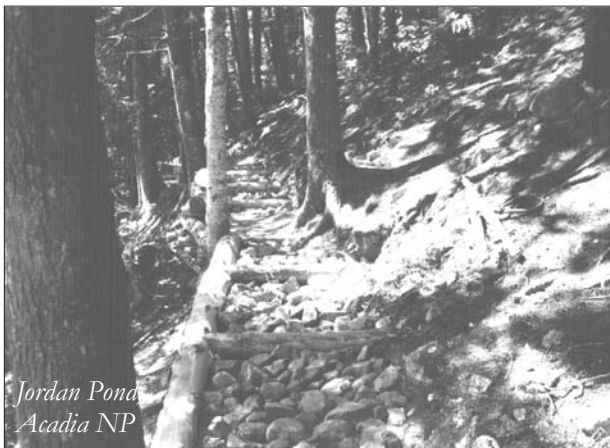
Figure 4.47. Log cribbing steps before receiving final top coat of gravel. The crushed rock that fills the crib facilitates trail drainage.

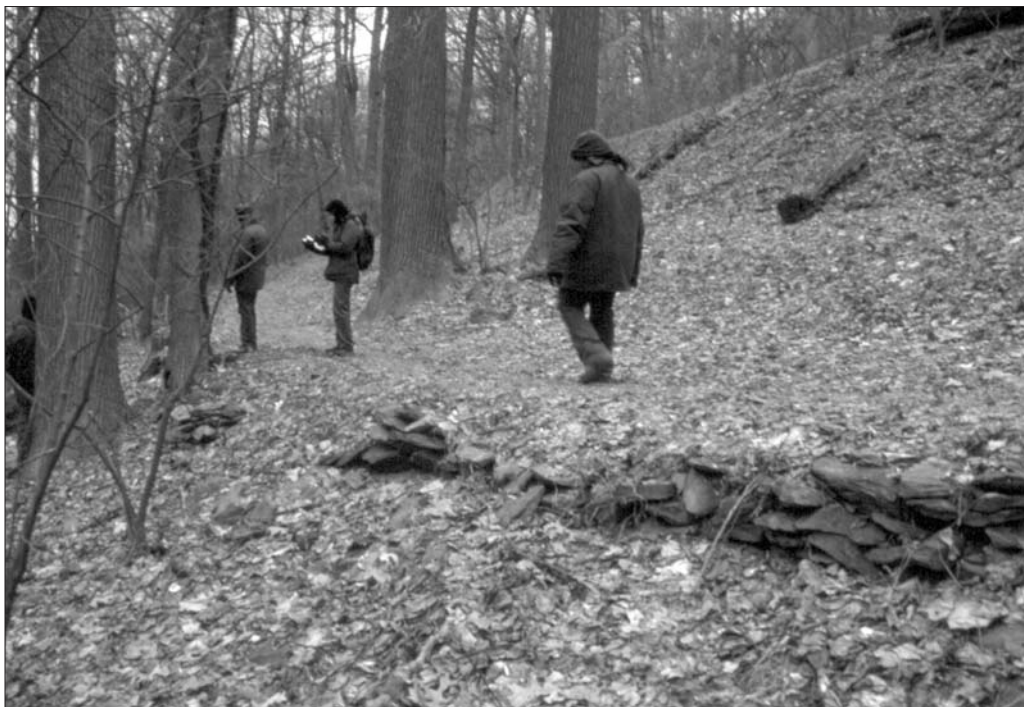
Figure 4.48. The retaining wall on Mount Joy Trail J is roughly sixty feet long and needs rehabilitation by experienced stone masons.

Recommendation: Rehabilitate existing walls to preserve historic constructed features and to prevent loss of tread in steep areas.

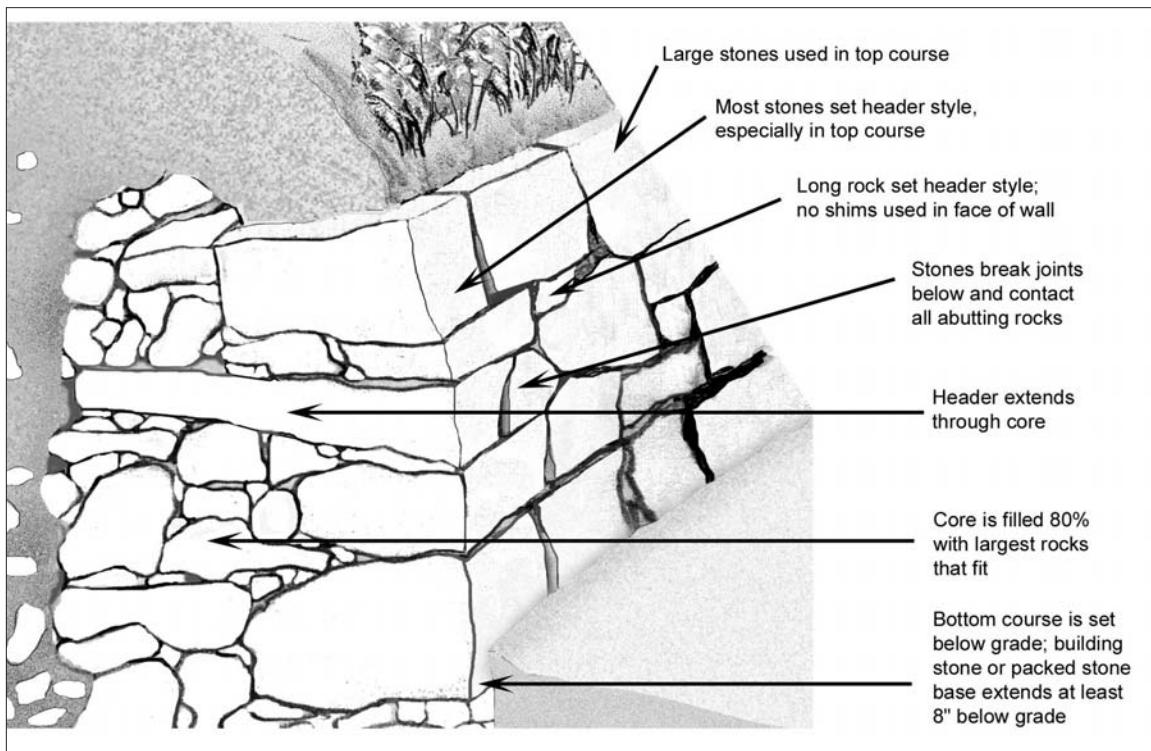
Figure 4.49. Specification for retaining wall construction from Acadia NP.

The foundation is the first tier of the wall, which is partially or fully beneath the ground. It should project four inches or more beyond the face of the main wall. At least fifty percent of each front foundation stone should be directly beneath the main wall; these stones should be at least twelve inches long in the direction perpendicular to the wall. Foundation stones should provide a flat, or slightly insloping, top surface on which to lay the main wall.

Lay stones with the length back into the wall (header style) as often as possible. Larger stones may be laid with their lengths running with the face of the wall (stretcher style), but only if they provide at least eight to ten inches of width in the face of the wall. The tops of wall stones should provide level or generally backsloping surfaces on which to lay the next stones. Lay stones so that they transfer their weight into the wall below and the material behind, rather than away from the wall, which can cause stones to tumble out of the wall or lean away from their loads instead of back into them. Every seam created by stones laid side by side should be broken or spanned by a single stone which covers the seam and has contact with each of the stones beneath it. Unbroken joints are called “running joints” or “stack bonds” and are usually the first areas to fail in a retaining wall.

The core is the area between the face of the wall and the material being retained by the wall. Though unseen, it is an essential part of the wall, providing internal drainage, mass and structural cohesiveness to the wall. Poorly built core with small stones just thrown in behind the wall, or lack of a core, are perhaps the most common causes of retaining wall failure.

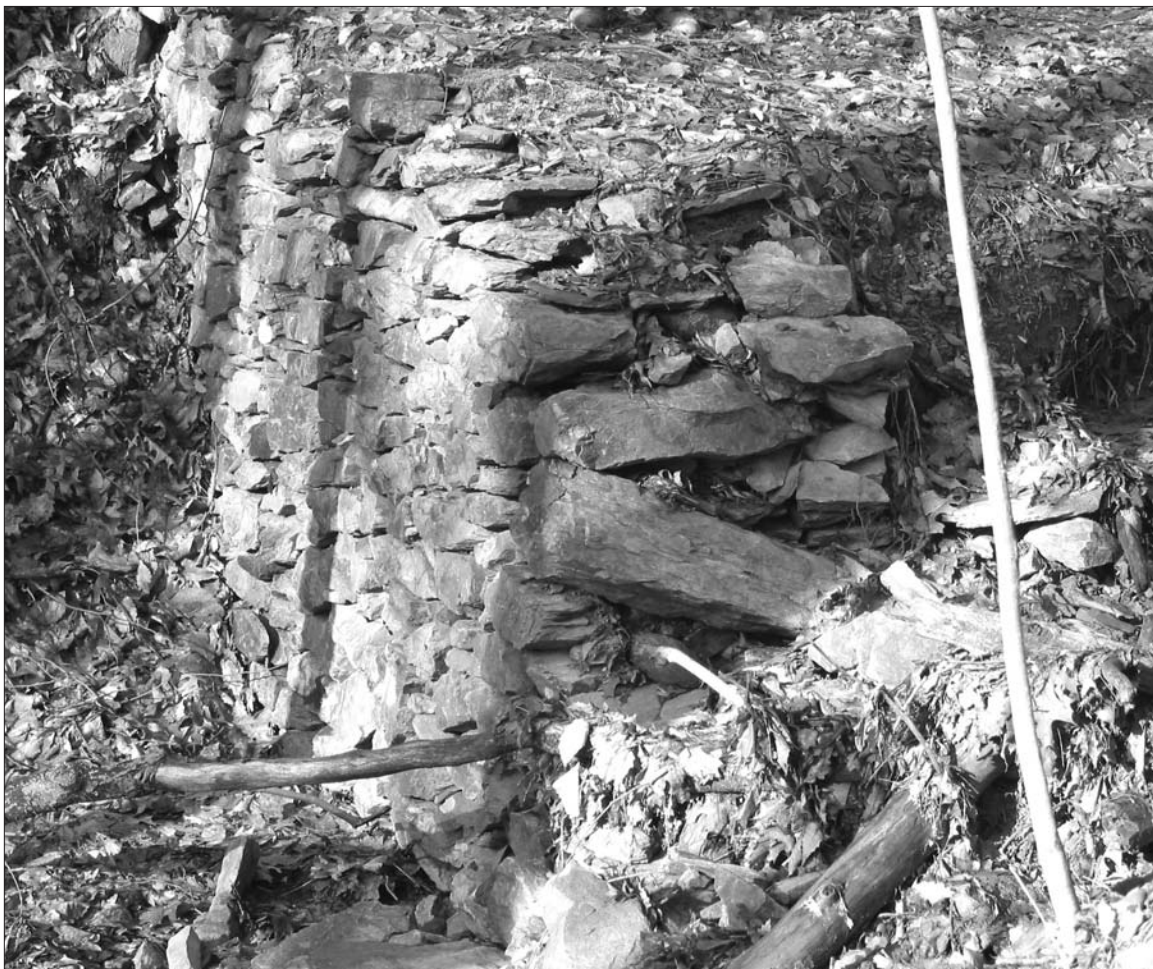
Figure 4.50. Though this dam wall on the Yellow Springs Trail Network has collapsed due to severe stream bed erosion and lack of maintenance, it was originally well-constructed: note the long headers stretching deep into bank, and the packing of core behind headers.

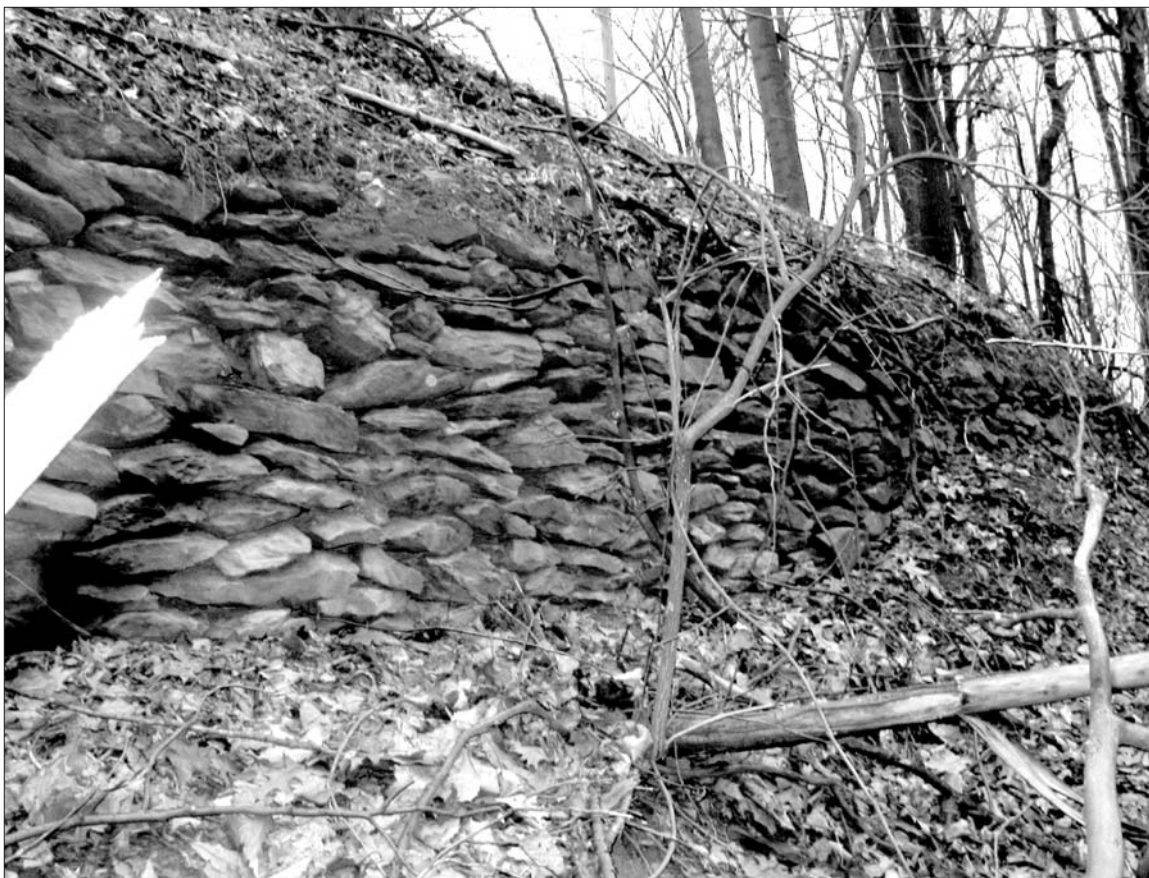
Figure 4.51. The wall above Mount Joy Trail J was originally well-constructed. Despite the middle section of the structure leaning outward due to the weight of the load behind the wall, overall it is still in fair condition.
